Project Overview

Project Objectives

Metamora Crescent Construction

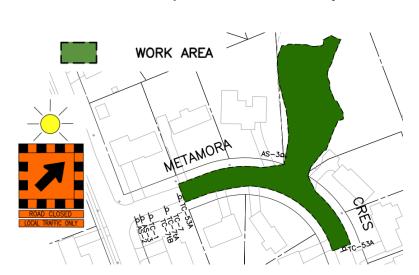
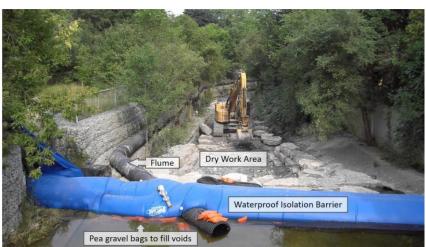
- Metamora Crescent will be closed to local traffic only, access to adjacent houses will be maintained
- Contractor to install tree protection fencing, sediment control fencing, and wildlife exclusion fencing (keeping rodents, amphibians, reptiles and other critters out of the work zone)
- Contractor will mobilize sewer and creek isolation and bypass pumping to ensure work is completed in the dry

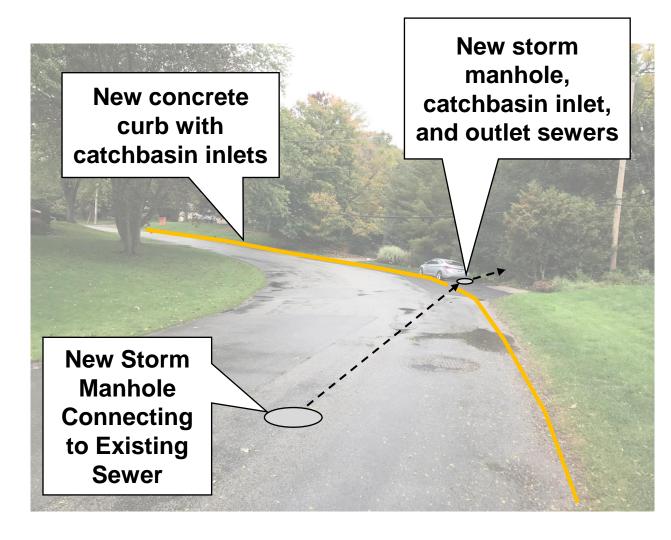
- New curb/gutter and catchbasin inlets will be constructed on north/east side of Metamora Crescent
- New storm sewer on Metamora and new outlet sewer leading into the ravine
